NX700 breathing regulators first stage voluntary product recall notification

All NX700 regulators are being removed from the market due to an identified potential life safety issue.

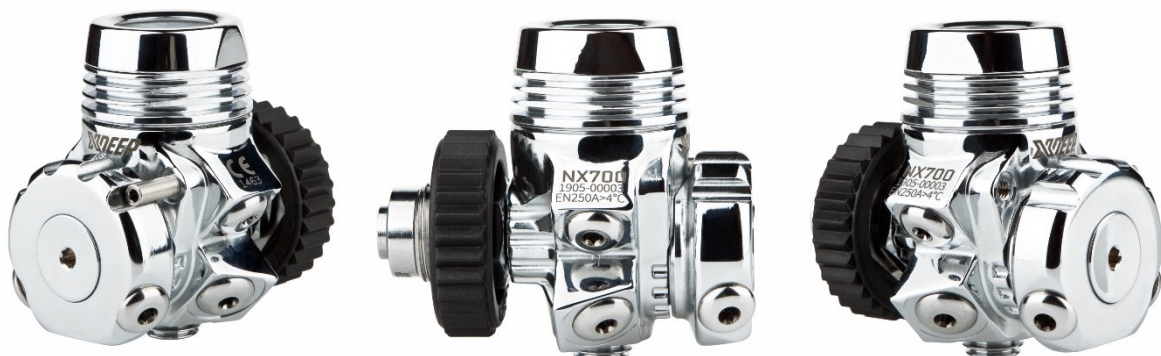
All NX700 1st stages are subject to this recall. The model number is clearly indicated above the LP port on the unit's body.

If you own an NX700 regulator, **immediately stop using it** and contact the dealer where you purchased it, or directly contact XDEEP at support@xdeep.pl for more information regarding the next steps.

- a. Exchange their NX700 1st stages with the turretless CX100 1st stage and receive the voucher worth 100 EUR for the future purchase of XDEEP products.
- b. receive a full refund for both 1st and 2nd stage.
